Learning From Incident Awareness Alert

| Alert NO | External Alert _OQ_0121102020 | Pattern | Lifting |

Description of the incident:

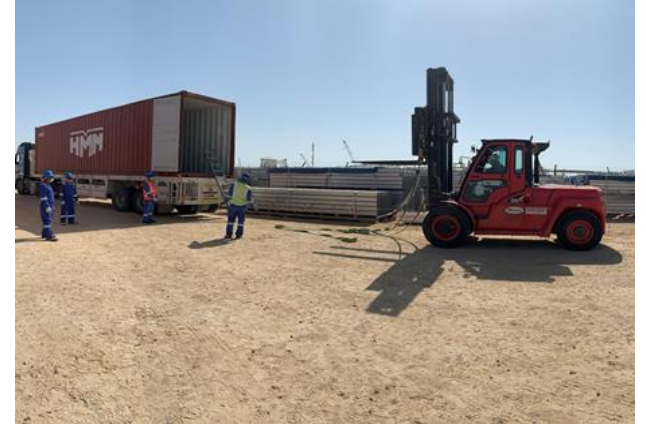
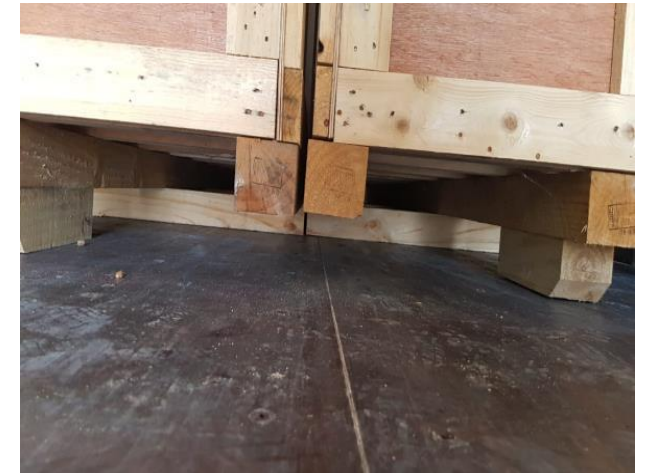
A crew was offloading palletized wooden boxes out of the 40-foot container loaded on a flatbed truck. In absence of the right machine, the crew decided to use a regular forklift and synthetic web slings to drag the boxes out of the container where one end of the sling was attached to the forklift mast and the other end was looped around blocks at the bottom of the wooden pallets. After offloading 5 boxes, the crew decided to drag the last 2 palletized boxes together at the same time. At this point, the flagman was standing outside of the truck and in close proximity (1.5m) from the back end of the flatbed trailer. As the forklift backed up and the boxes moved for about 2m, the blocks on the pallets got dislodged under tension, propelled towards the forklift and struck the flagman in the head.

Attempting to pull two pallets by the pallet blocks on the leading edge using a forklift which would only be held in by the securing nails.

- Ensure the lift plan and the risk assessment are in place.
- Ensure follow a proper method to load/off load pallets.
- Pallets are designed to be lifted and, they are not designed to be pulled along the ground.
- Ensure all participants are way from the line of fire.
- Ensure the equipment being used is appropriate for the job.
- Ensure the work area is clear before carrying out the operation.
- Ensure that people are competent for the job.
